QUAGE, KY.
N3730-W8307.5/7.5
1951
PHOTOGRAPHICALLY REPRODUCED

Landslides and related features interpreted from aerial photographs:
1:80,000 (black and white) 1977

LANDSLIDES AND RELATED FEATURES

OF THE QUAGE, KY. QUADRANGLE
by
William F. Outerbridge
1982
U. S. Geological Survey
OPEN FILE MAP 82-51 (E-7)

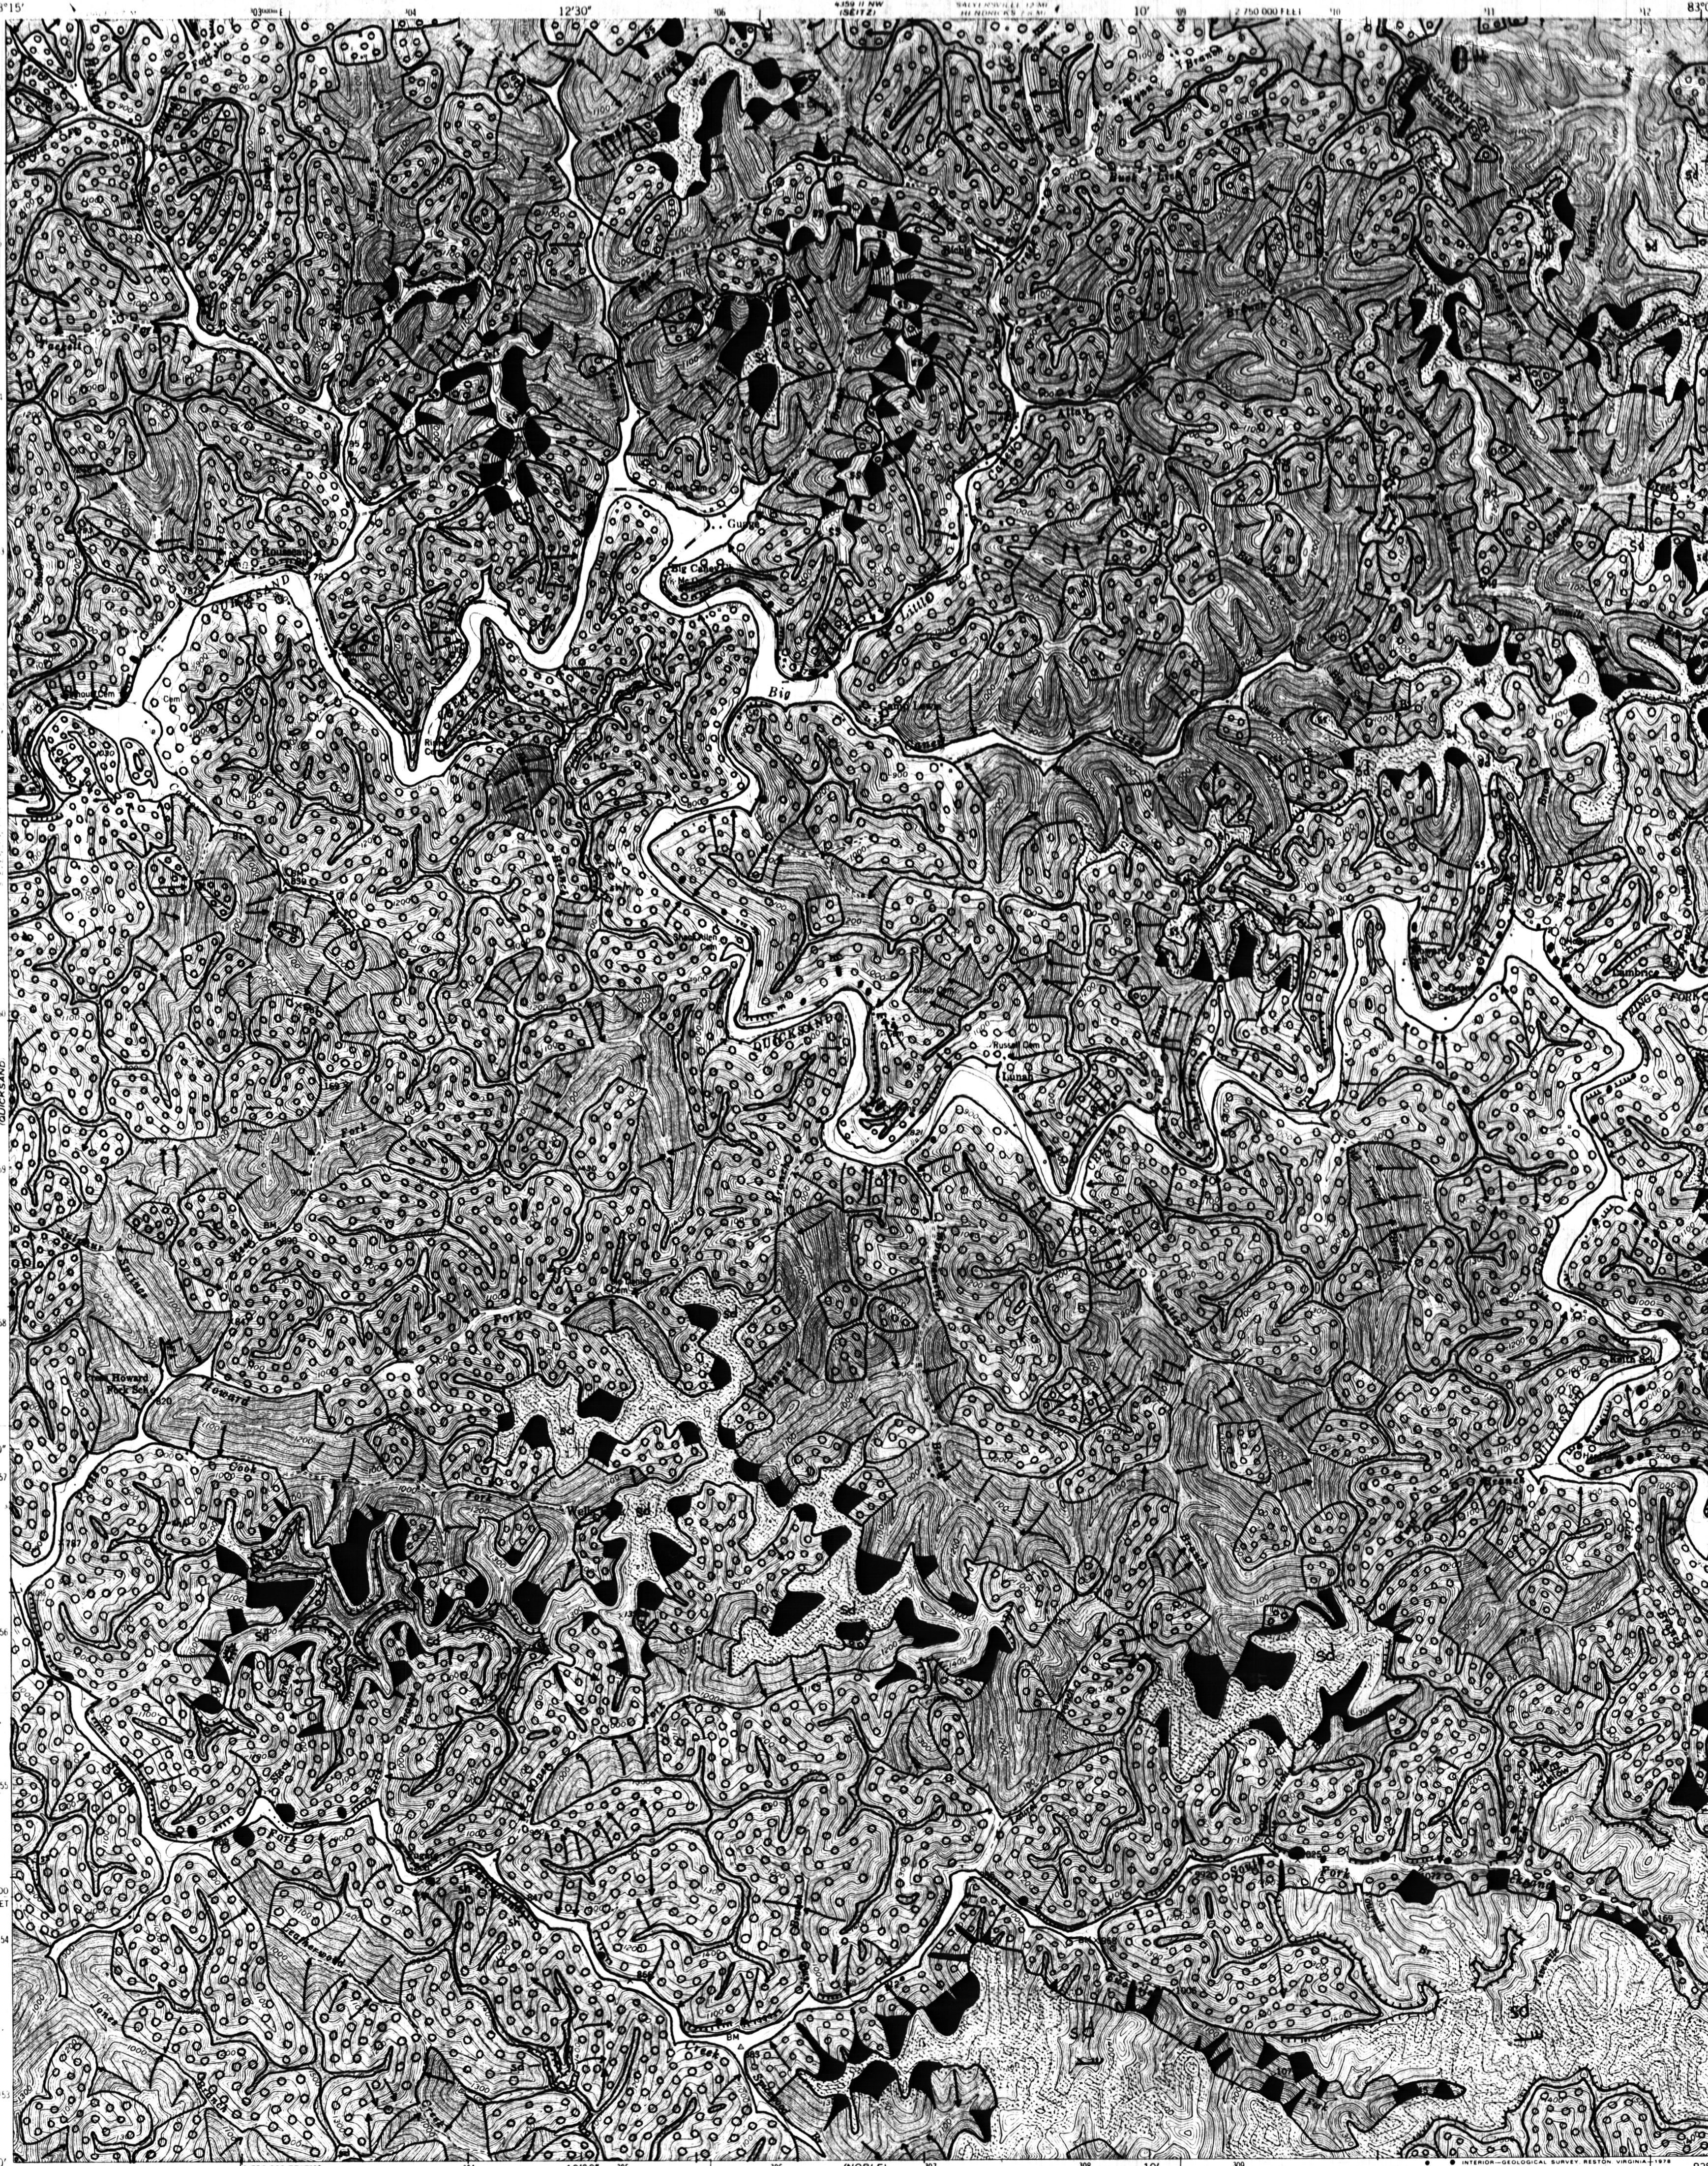
Photointerpretation and field check 1978,9
This report is preliminary and has not been reviewed for conformity with U. S. Geological Survey editorial standards.
Data on location of strip mines in part from:
Lee, K. Y., Danilchik, W., and Rice, C. L., 1977,
Geologic map of the Quage Quadrangle, Breathitt and Magoffin Counties, Kentucky; U. S. Geological Survey Geologic Quadrangle Map GQ-1416, scale 1:24,000.

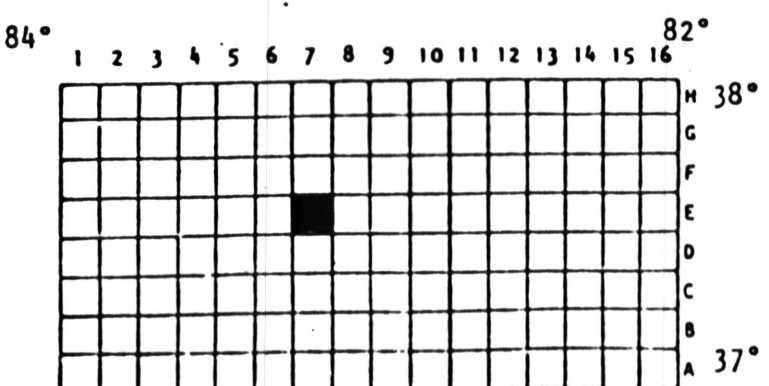
The first four digits of the open file number designate the specific 1:250,000 scale map sheet of which this quadrangle is a part. The last two digits designate the position of the quadrangle in a subdivision of the 1:250,000 scale map based on rows and tiers shown in the diagram to the right. The location of this quadrangle is shown by the black square.
